# T ECHNICAL INFORMATION

87942

November 2010

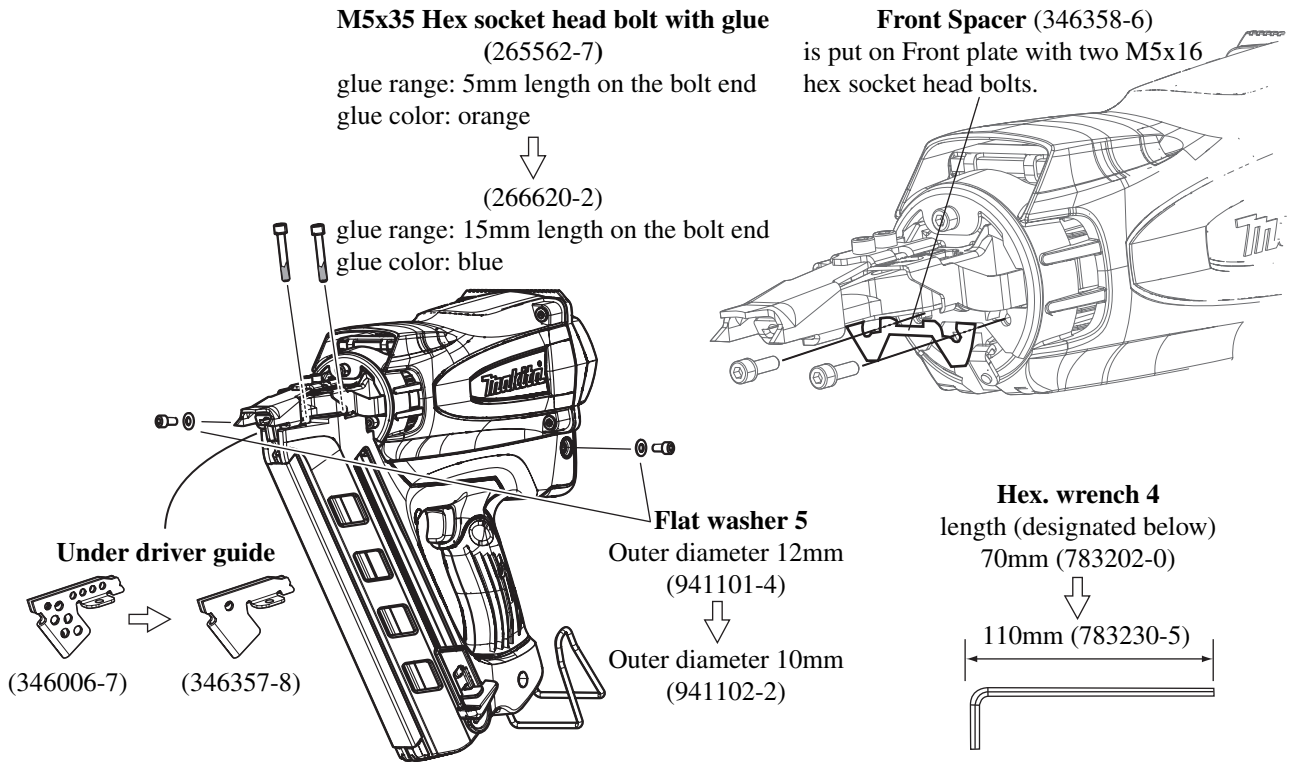
- Subject** ▶ Addition of Front Spacer,  
Change of Under Driver Guide, M5x35 Hex Socket Head Bolt, Flat Washer 5, Hex. Wrench 4
- For Models** ▶ GN900
- Country** ▶ All countries
- Description** ▶ For further improvement in durability of Cylinder head;
  - 1) Front spacer has been added.
  - 2) Under driver guide, M5x35 Hex socket head bolt, Flat washer 5 and Hex. wrench 4 have been changed.

**Note:** In case of Cylinder head failure, all the following parts have to be replaced.

In case of Under driver guide failure, Under driver guide and two M5x35 Hex socket head bolts have to be replaced.

Item No.	Current part	Q'ty	I/C	New part	Q'ty	Note
100				Front Spacer 346358-6	1	
020	Under Driver Guide 346006-7	1	←	Under Driver Guide 346357-8	1	
009	Hex Socket Head Bolt M5x35 265562-7	2	←	Hex Socket Head Bolt M5x35 266620-2	2	
068, 096	Flat Washer 5 941101-4	2	←	Flat Washer 5 941102-2	2	The current remains available.
A02	Hex. Wrench 4 783202-0	1	←	Hex. Wrench 4 783230-5	1

The arrow ← means that the new part can be substituted for the current.

From serial No. 15772
